สรุปกิจกรรม Coffee hour for you

หัวข้อเรื่อง "การนำเสนอผลงานทางวิชาการในระดับนานาชาติ"
เมื่อวันพุธที่ ๒๔ มิถุนายน ๒๕๕๘ เวลา ๑๓.๐๐-๑๔.๓๐ น.
ณ ห้องประชุมคณะสถาปัตยกรรมศาสตร์และการออกแบบสิ่งแวดล้อม
โดย อาจารย์ ดร.วิทยา ดวงธิมา

การนำเสนอผลงานวิชาการระดับนานาชาติ

CONCEPT AND PRACTICE OF CULTURAL HERITAGE CONSERVATION UNDER FLOOD DISASTER: A CASE STUDY OF AYUTTHAYA, THAILAND

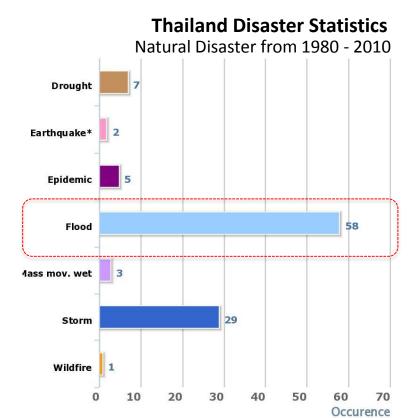
Fig. Thailand Disaster Statistics sources: by PreventionWeb, 2013

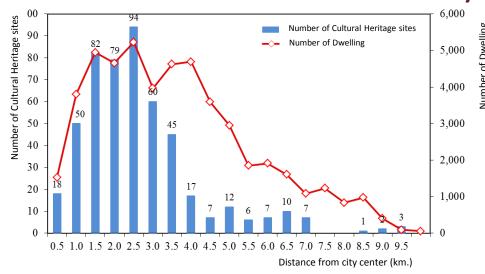
Fig. The relationship between number of cultural heritage sites, number of dwelling and distance from city center.

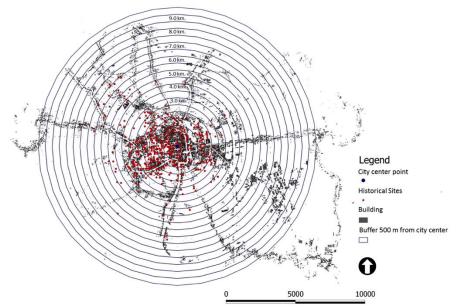
Fig. The Distribution of Cultural heritage sites Around Ayutthaya Historical City.

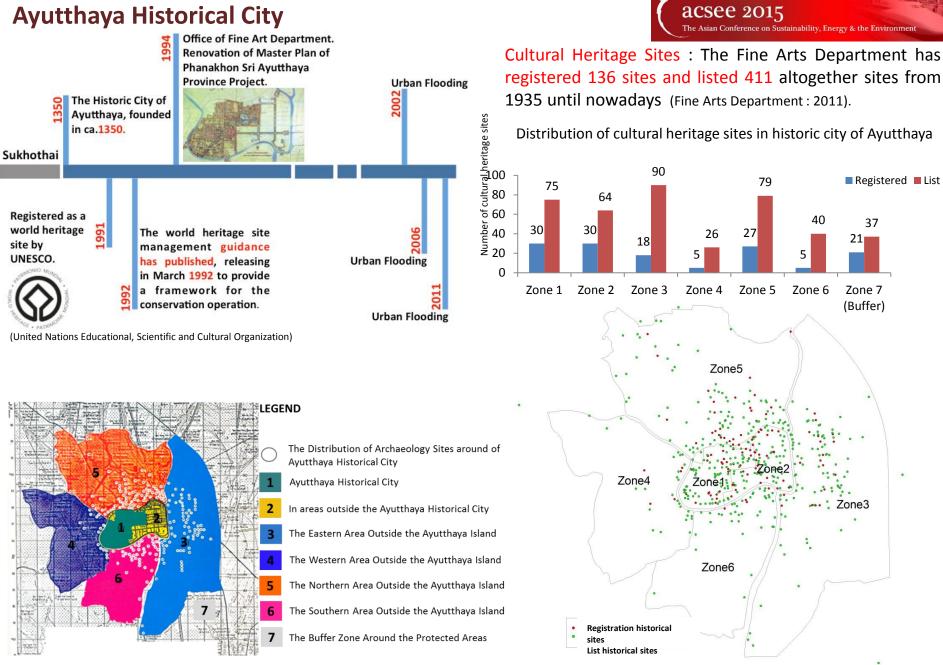
Fig. Zoning and the distribution of Ayutthaya Historical City.

Fig. The Registered cultural heritage sites and the Listed cultural heritage sites.

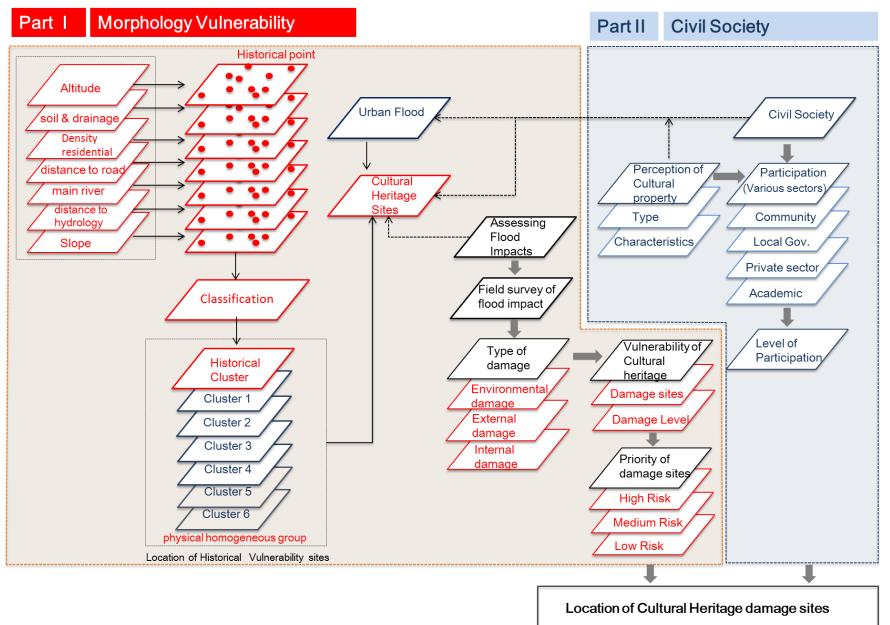
Methodological Framework for urban morphology types

To classify the morphology property of homogeneous group on cultural heritage sites

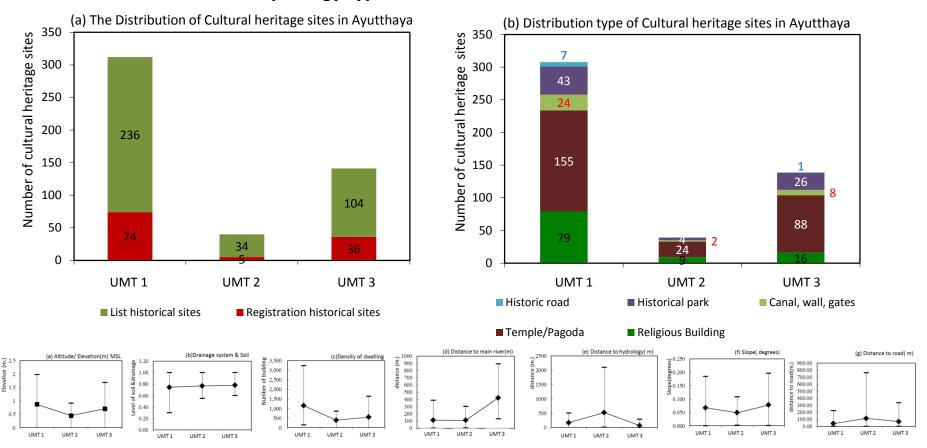
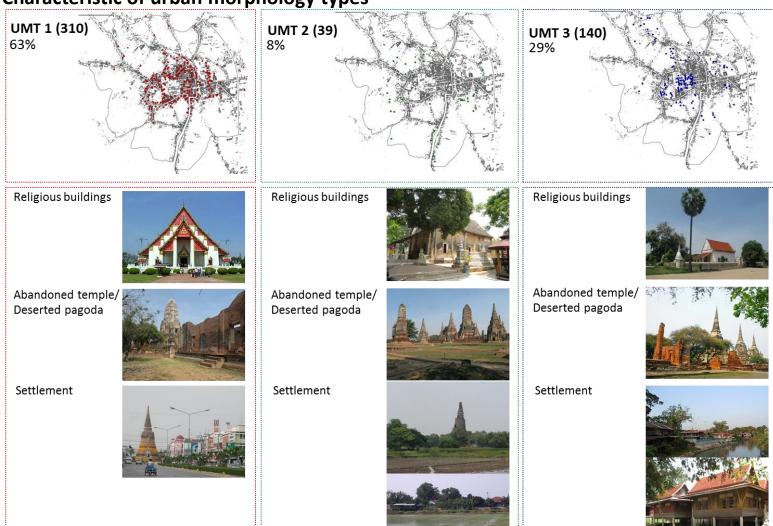
Classification of urban morphology types

UMT 1 High above mean sea level 0-1.98 m. and High density of dwellings

UMT 2 High above mean sea level 0-0.91 m. and low density of dwellings

UMT 3 High above mean sea level 0-1.68 m. and medium density of dwellings

Туре	Characteristic									
	Elevation(m.)	Drainage system & Soil	Density of dwellings (total)	Distance to main river(m.)	Distance to hydrology(m.)	Slope(degrees)	Distance to road(m.)			
UMT 1	Height above mean sea level 0 - 1.98 m.	0.30-1.00	147- 3,223 (High Density)	0 - 385	0 - 498	0 - 0.184	0 - 221.42			
UMT 2	Height above mean sea level 0 - 0.91 m.	0.55-1.00	0 - 851 (Low Density)	5 - 300	0 -2093	0.002- 0.108	0 - 762.27			
UMT 3	Height above mean sea level 0 - 1.68 m.	0.60-1.00	0 - 1640 (Medium Density)	129 - 892	0 - 282	0.001 - 0.196	0 - 335.34

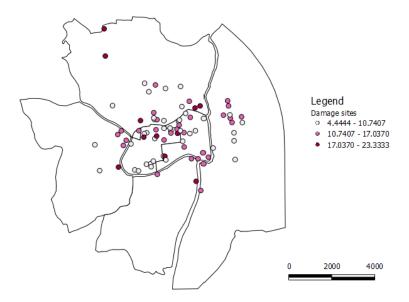
Fig. Flo	od impact of σ	cultural heritage vulnerabi	lities.

-	High Risk (181-240)	Med Risk(121-180)	Low Risk(60-120)	Total
	17.04-23.33(%)	10.74 - 17.03 (%)	4.44 -10.73(%)	<u>-</u>
Damage site	12	30	42	84
Average	214.29	146.77	96.74	125
Min	190	130	60	60
Max	240	180	120	240

- UMT 2 is high vulnerability, UMT 3 is Medium Vulnerability and UMT 1 is low vulnerability.
- Found 3 types of damage; environmental damage, external damage and internal damage.
- The levels of damage; high risk, medium risk and low risk respectively, are also assigned.
- Found 84 CHS were assessed as damage; High risk 12 sites, Med Risk 30 sites and low risk 42 sites.

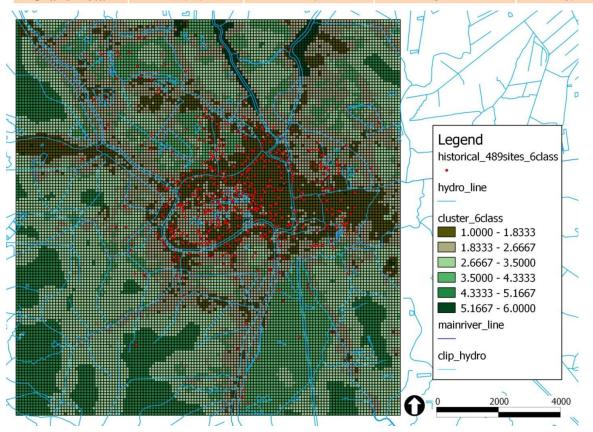
These seven factors are employed as indicators for setting the priorities of vulnerability damage sites.

Found 6 characteristic of UMT

Fig. Characteristic of urban morphology types and cultural heritage sites[Author, 2013].

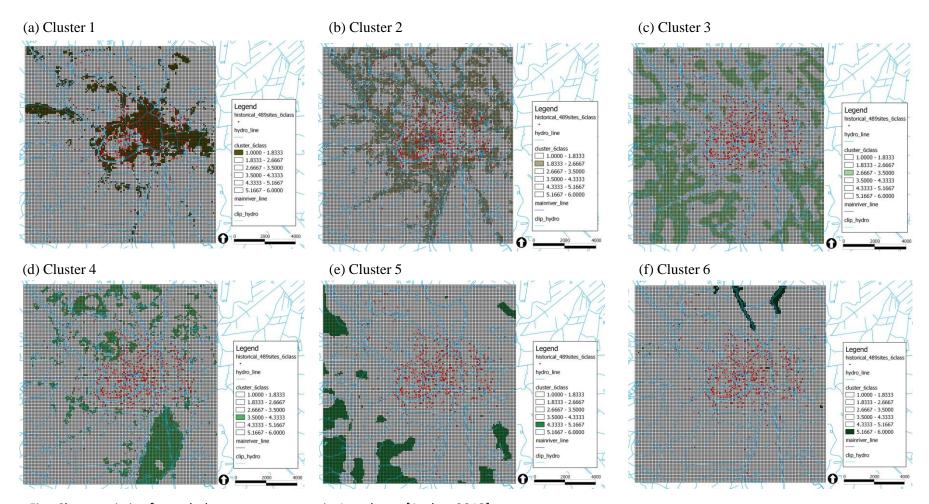
Fig. Characteristic of morphology property types in Ayutthaya. [Author,2013]

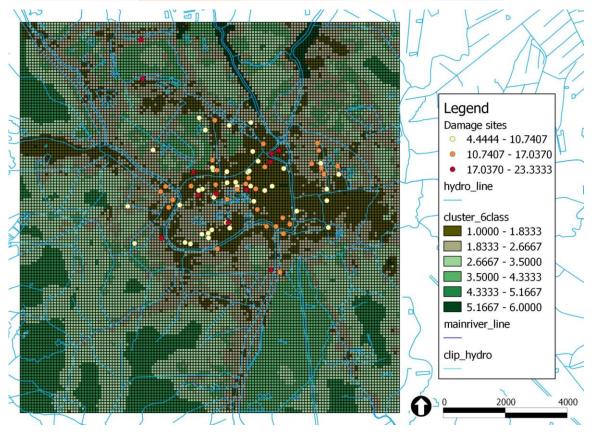
- From the previous result found 84 CHS in study area were assessed as damage sites.
- Found 4 cluster of characteristic of UMT had damage sites

Fig. Characteristic of urban morphology types and cultural heritage damage sites[Author, 2013].

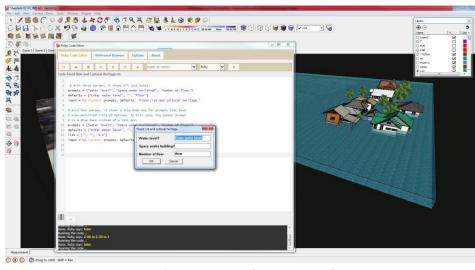
Fig. The support scheme of the PCH tool [Author, 2013].

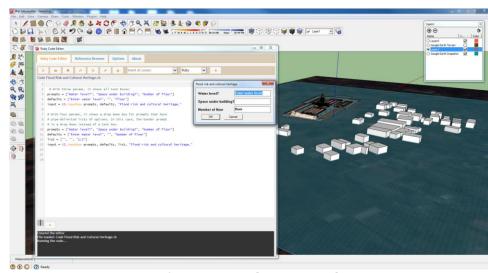
Fig. The support scheme of the PCH tool [Author, 2013].

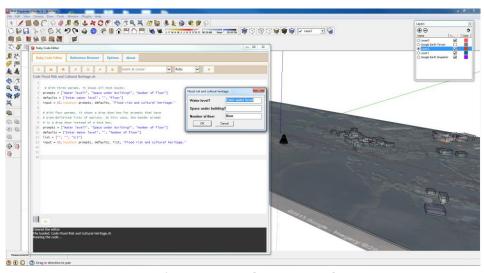
Fig. The support scheme of the PCH tool [Author,2013].

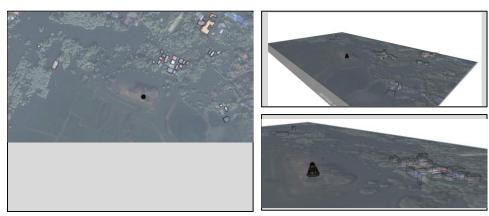
Fig. Characteristic of urban morphology type 3 (cluster 3) [Author, 2013].

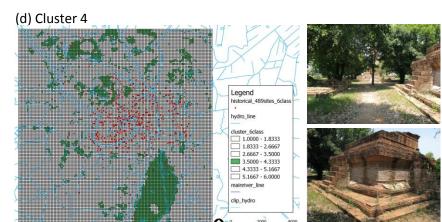
Fig. Characteristic of urban morphology type and damage sites(class 4) [Author, 2013].

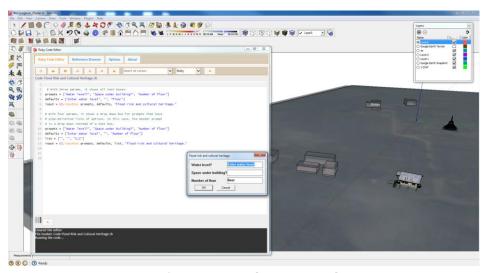
Fig. The support scheme of the PCH tool [Author,2013].

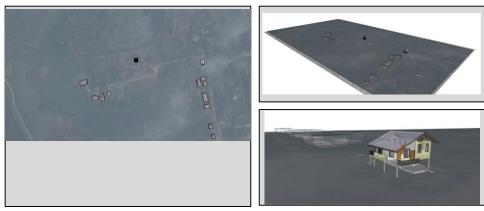
Fig. Characteristic of urban morphology type 4 (cluster 4) [Author, 2013].

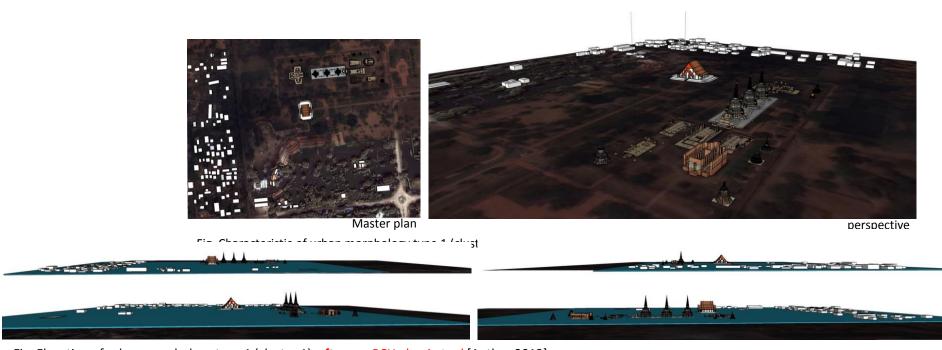
Fig. Elevation of urban morphology type 1 (cluster 1) after use PCH plug-in tool [Author, 2013].

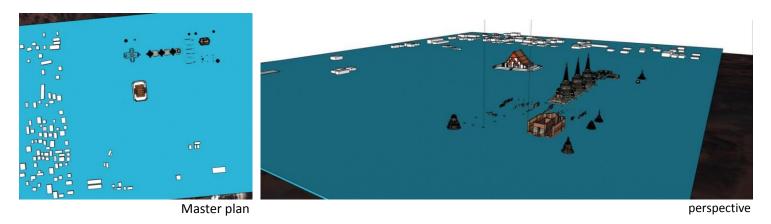
Fig. Characteristic of urban morphology type 1 (cluster 1) after use PCH plug-in tool [Author, 2013].

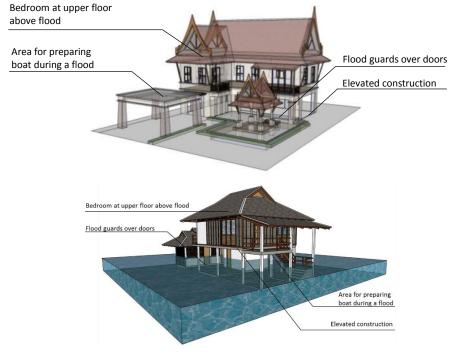
Fig. Architecture Design Measures [Author, 2013].
